## TOURING COIL SUSPENSION SHOCK BOLT REPLACEMENT

| Recall Number | 26E-032 | | |
| Product: | Curt Touring Coil Suspension | | |
| Date: | 05/27/2026 | Labor Rate: | Tandem Axle - 0.8 hrs<br>Triple Axle - 0.9 hrs |

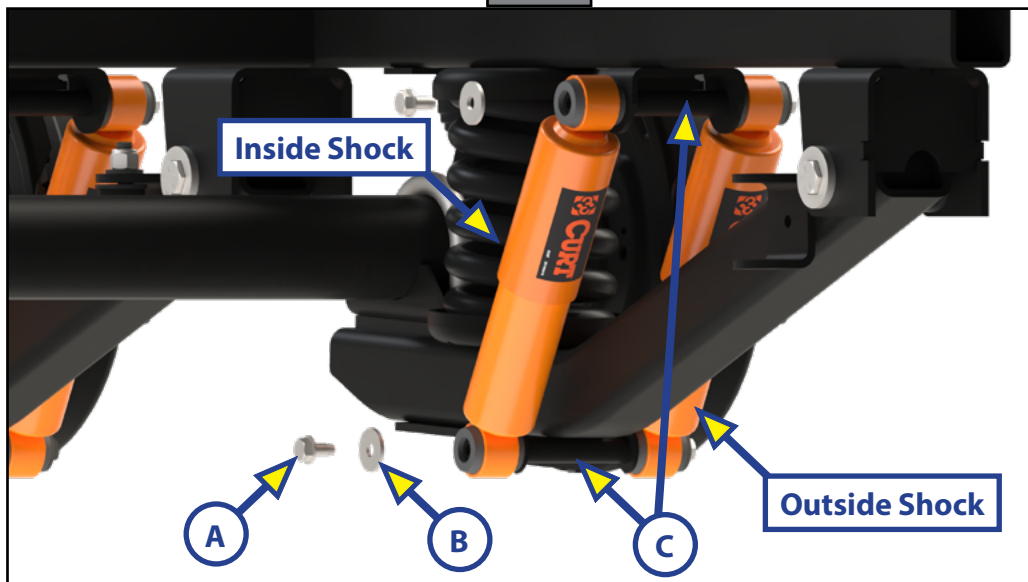
**Fig. 1**

Lippert has identified instances where CURT® Touring Coil Suspension (TCS) shock bolts may have been improperly torqued during installation. Although we are confident it is a small quantity, out of an abundance of caution, Lippert is issuing this Safety Recall to replace all shock bolts on units equipped with factory-installed TCS on Lippert chassis manufactured prior to April 23, 2026.

1. Starting with the inside shocks, loosen and remove the two existing  $\frac{3}{8}$ "-16 x  $\frac{3}{4}$ " thread forming screws (Fig. 1A) and washers (Fig. 1B) securing each shock absorber onto its posts (Fig. 1C). Retain washers (PN 249853) for reinstallation in Step 2.

2. Reinstall previously-removed washers onto two new  $\frac{3}{8}$ " - 16 x  $\frac{3}{4}$ " Grade 8 hex head bolts.
