NXG FRAME BY NORCO INDUSTRIES

The Next Generation in RV Frame Technology

CONNECT | CONNECT SE

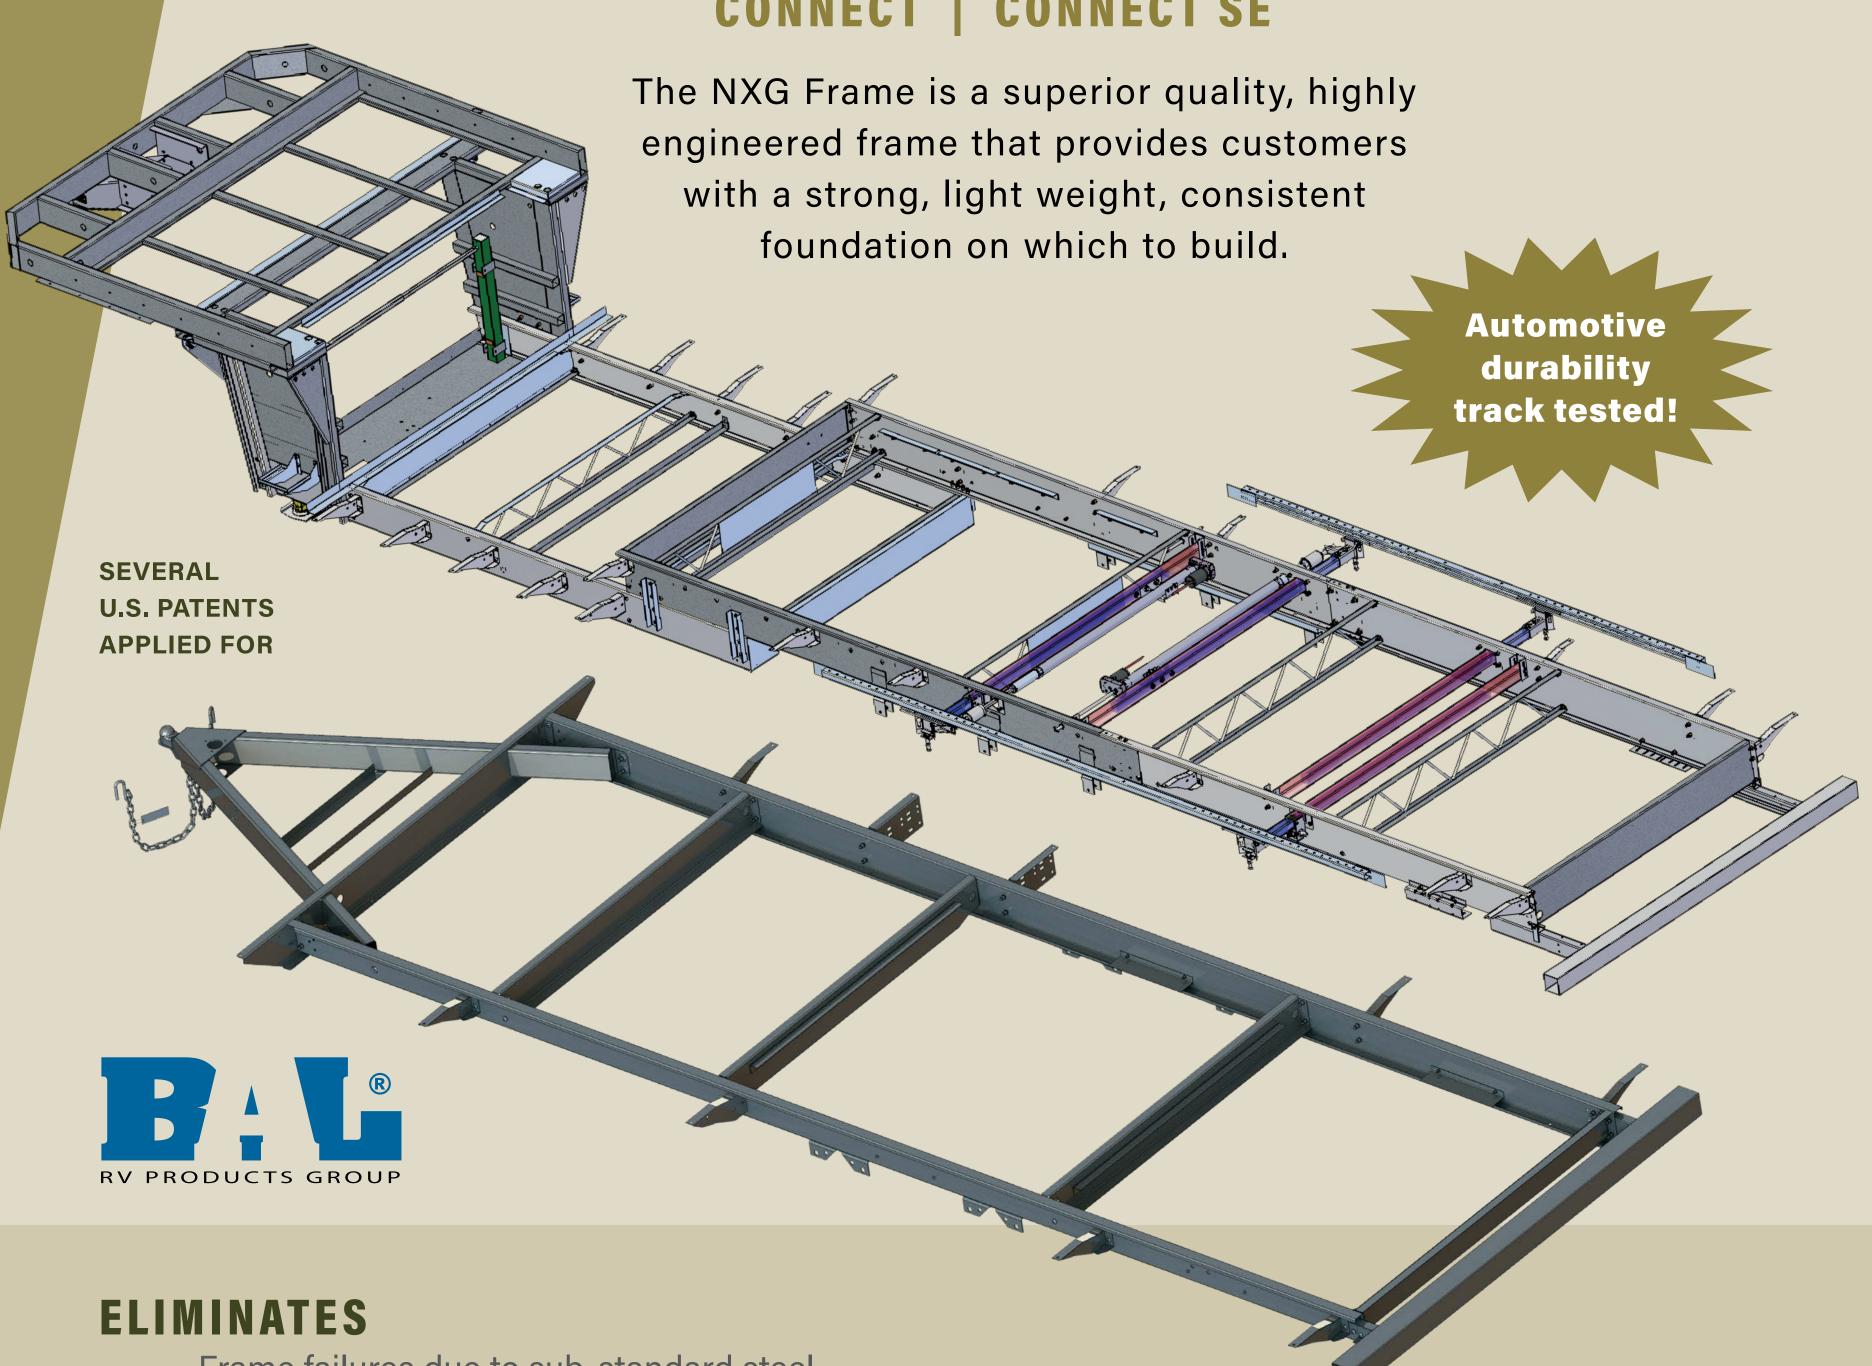
- Constructed with HSLA High Strength Low Alloy Prime Steel with specifically controlled properties.
- Designed to accommodate both fifth wheel and travel trailer configurations.
- CNC controlled rail fabrication allows placement of components precisely where the manufacturer wants them.
- Manual welding is minimized. Common components are robotically welded for consistent quality.
- All fastened components are joined with Huck® fasteners. Huck® fasteners provide consistent clamp load.
- CNC controlled camber.
- Designed with flush floor slideouts, ensuring no rise between slideout and main floor for easier movement throughout the unit.
